# Dukes Restoration

BY CLIVE FEWIN  
JOURNALIST

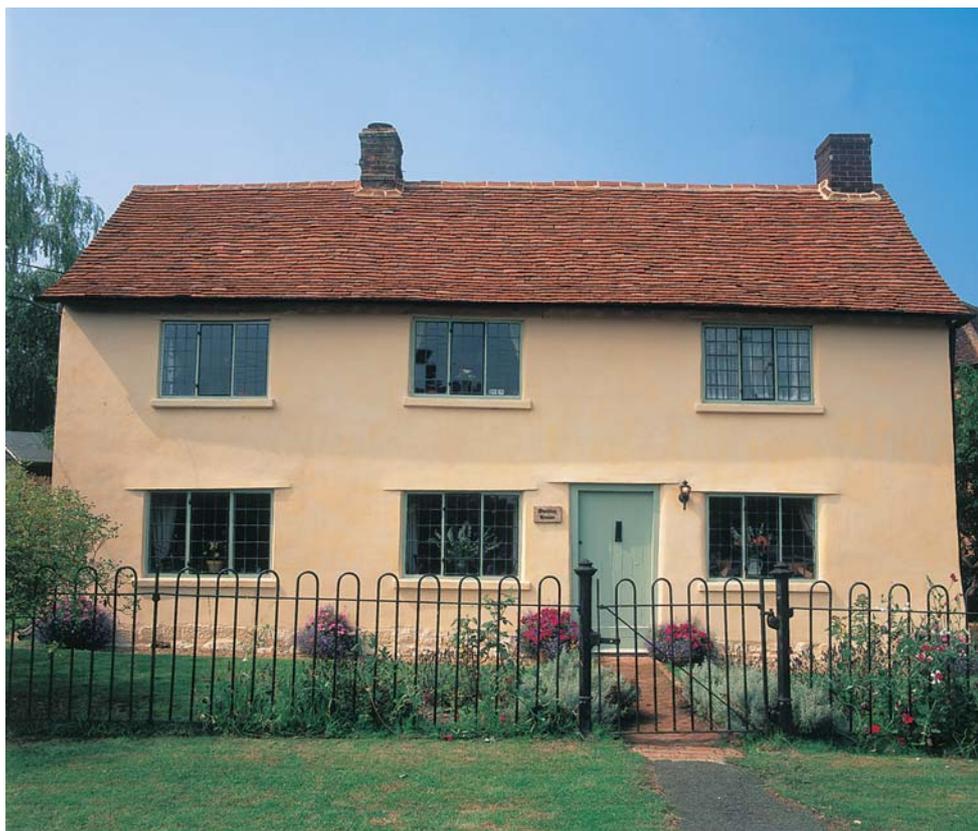
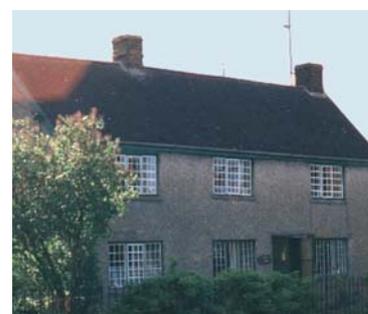
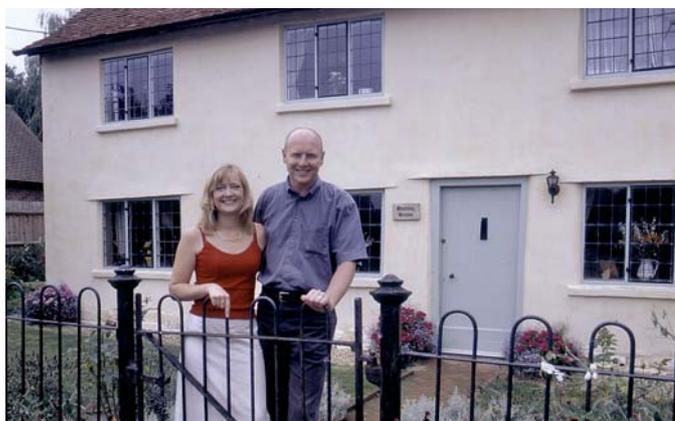
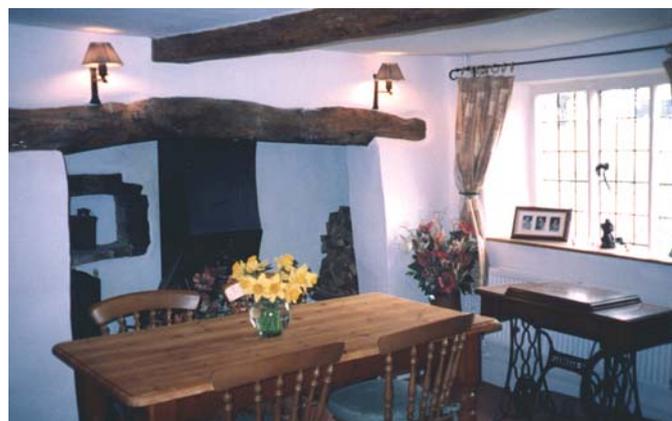
The house when Robin and Kate bought it

The inglenook fireplace in the dining room had been completely filled in: its rediscovery was a major triumph for Robin and Kate

Outside, after stripping off all the pebbledash, they had some remedial work to do where there had been a collapse in the front wall at the north corner. They used unfired clay bricks from a local brickworks to fill this. This technique meant minimal shrinkage. Where repairs were needed in smaller, more localised areas of the external walls they mixed their own wychert using clay from the garden mixed with straw and a little water. They then covered the outside with a lime render.

Their crowning glory was the large inglenook fireplace they rediscovered in the living room, which had been completely filled in. “We knew it would be here, but restoring it was still a pretty big job,” Kate said. The material we took out filled two skips!”
