The saving of Cruck Hall

by Clive Fewins

Fourteen years after purchasing the run-down Grade II listed former pub and hairdressing salon a few doors away from his home, former motor engineer and physics teacher Terry Randall is preparing to move into the building, which he has revealed in all its glory as a 15th century cruck-framed hall house.

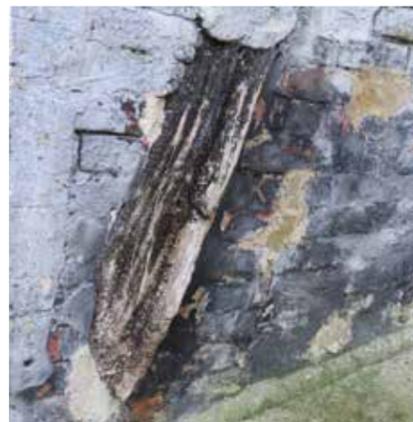
The only external clue to the long history of the house was the base of an ancient cruck that showed at the bottom of the north-facing wall. This can be seen low down on the extreme left of the picture

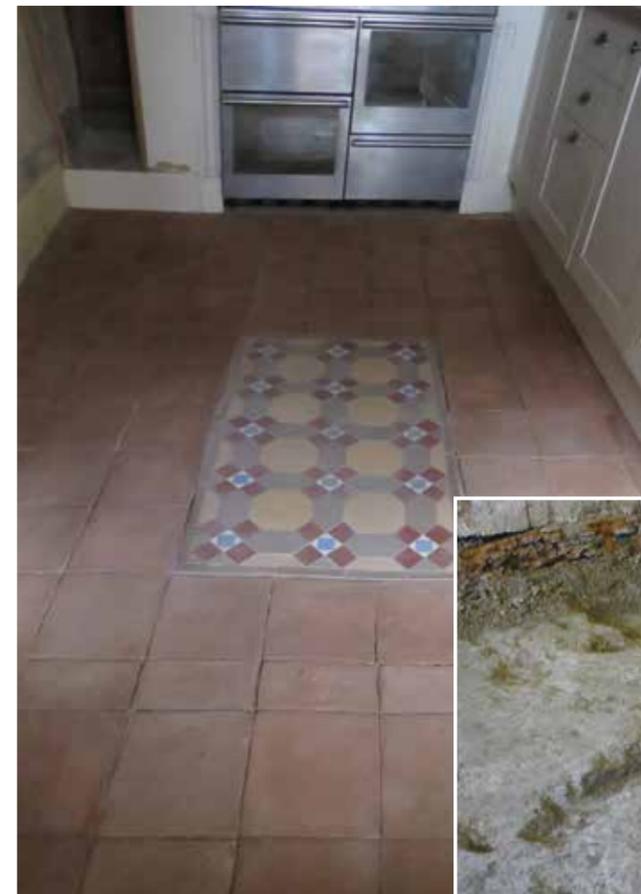
The kitchen floor today. The large clay tiles came from a local church that was being refurbished. They are very old and some display finger and thumb prints of the makers. The smaller floor tiles are Victorian and came from a 19th century house in the town that was being demolished

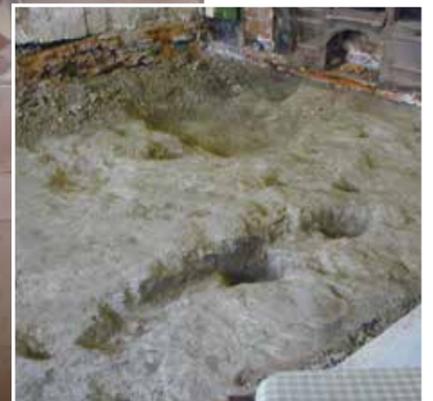
The old kitchen floor had been ruined by masonry nails driven through it. When Terry took it up he dug down to the bedrock, a marl with more than a hint of history about it. This was confirmed when he found a Roman coin minted in this country (Colchester) and dated AD290. When Terry and his wife Andrea bought the house there was a shattered old range and side oven in this room. They can just be seen in the photograph

One of Terry's first tasks on taking possession of the empty building was to replace the kitchen floor, which necessitated digging up the old. In the course of this work he made a number of interesting finds. He also commissioned some dendrochronology in the house, which produced a date of 1448/9 for some of the cruck blades, plus one of the kitchen wall timbers.

His most fascinating discovery beneath the floor was a Roman coin dated AD 290. This find supports previous archaeological evidence of Roman activity in Wantage.

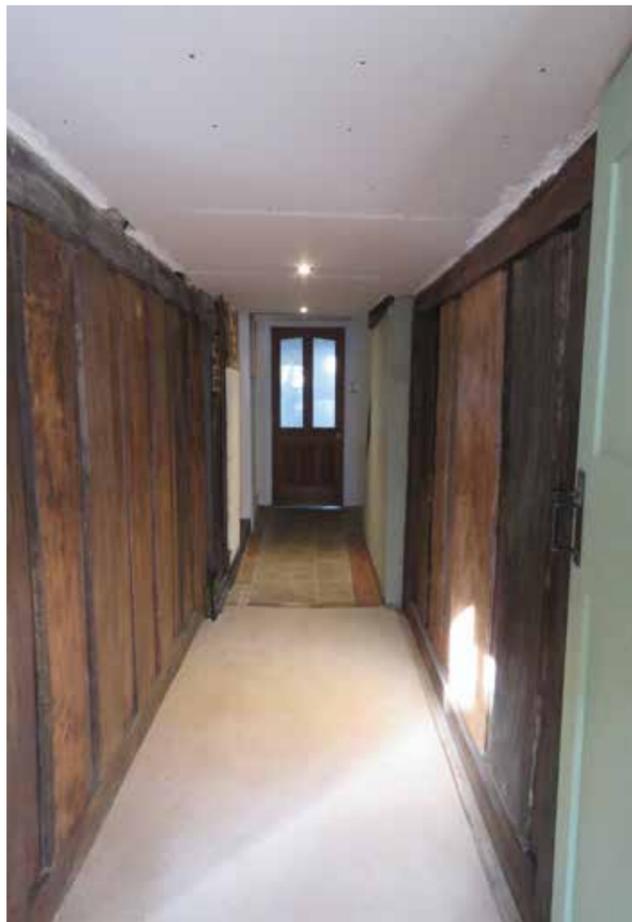
The rebuilt cross passage. Terry is fairly certain that one of the replaced screens is back in its original position but the other has been added beneath a later ceiling beam. The elm boards all came from different local sources found by Terry and his architect son, Christian

Probably the best architectural salvage finds were the hardwood (mainly elm) planks from which Terry constructed the plank and muntin screens that line the hallway. “One of these is probably on the same spot as the original!” Terry said. “It looked from the slots under the tie-beam as though there had been an original screen on the one side. The other I placed beneath a later structural beam.”

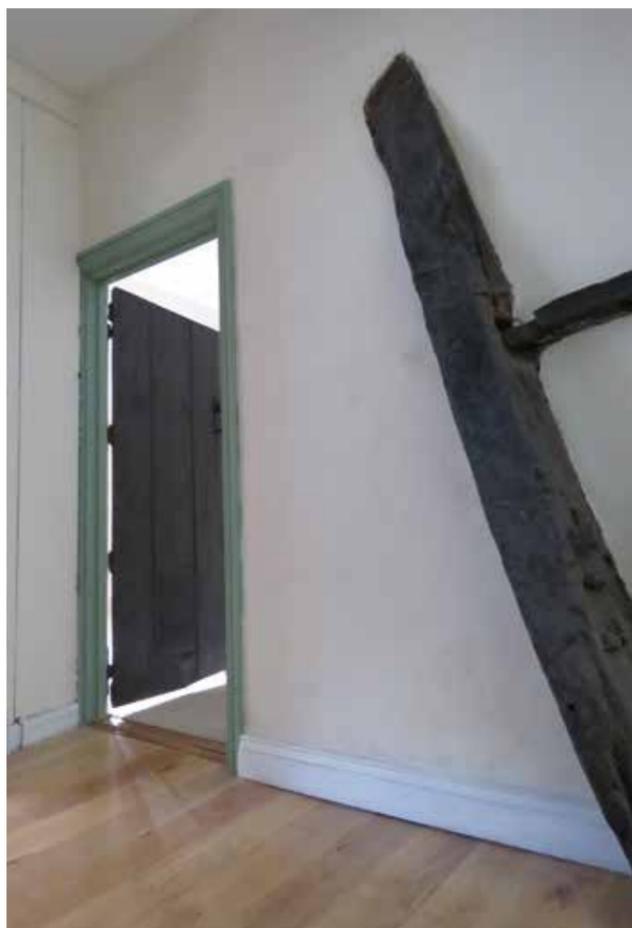
The first floor landing area cruck. It shows the lean caused by the racking that Terry believes to date from about the end of the sixteenth century

One thing that puzzles him is the cause of the severe racking which afflicted the building from, he believes, about the end of the 16th century. Racking is when a building becomes unstable and gradually begins to lean sideways. It is usually caused when something dramatic happens. Terry thinks it might have been caused by the removal of some of the original windbraces when the open hall style of the building was changed in the sixteenth century.

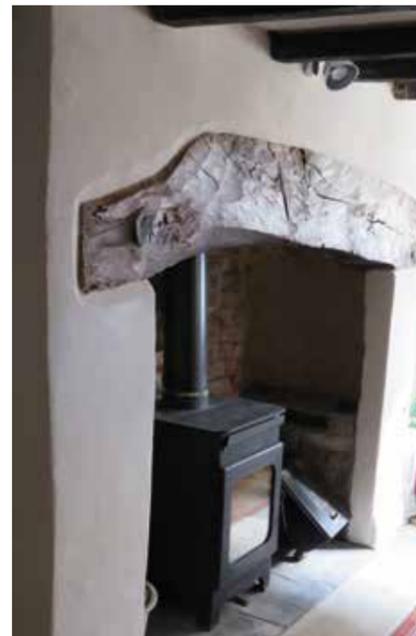
The dining room inglenook. When Terry started work there was a Victorian fireplace here. He believes the inglenook, which he repaired and restored, dates from about 1600 and served as a replacement for the central fire when this style and its successor, the smoke hood, fell out of use

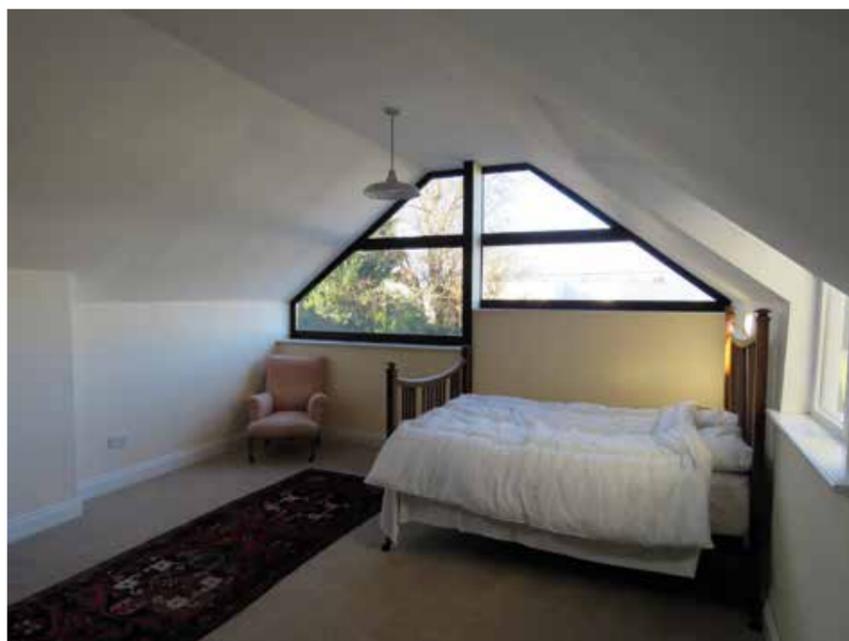
The new bedroom at the rear. This was the section that needed a steel frame to hold up the new section of roof

The task was made even bigger by Terry’s decision to add an upper floor at the rear comprising one large bedroom. He built this himself. The only professional building help he received throughout the project was assistance from two men who helped erect the steel frame that holds up the roof of the extension.
