A labour of love - from afar

BY CLIVE FEWINS

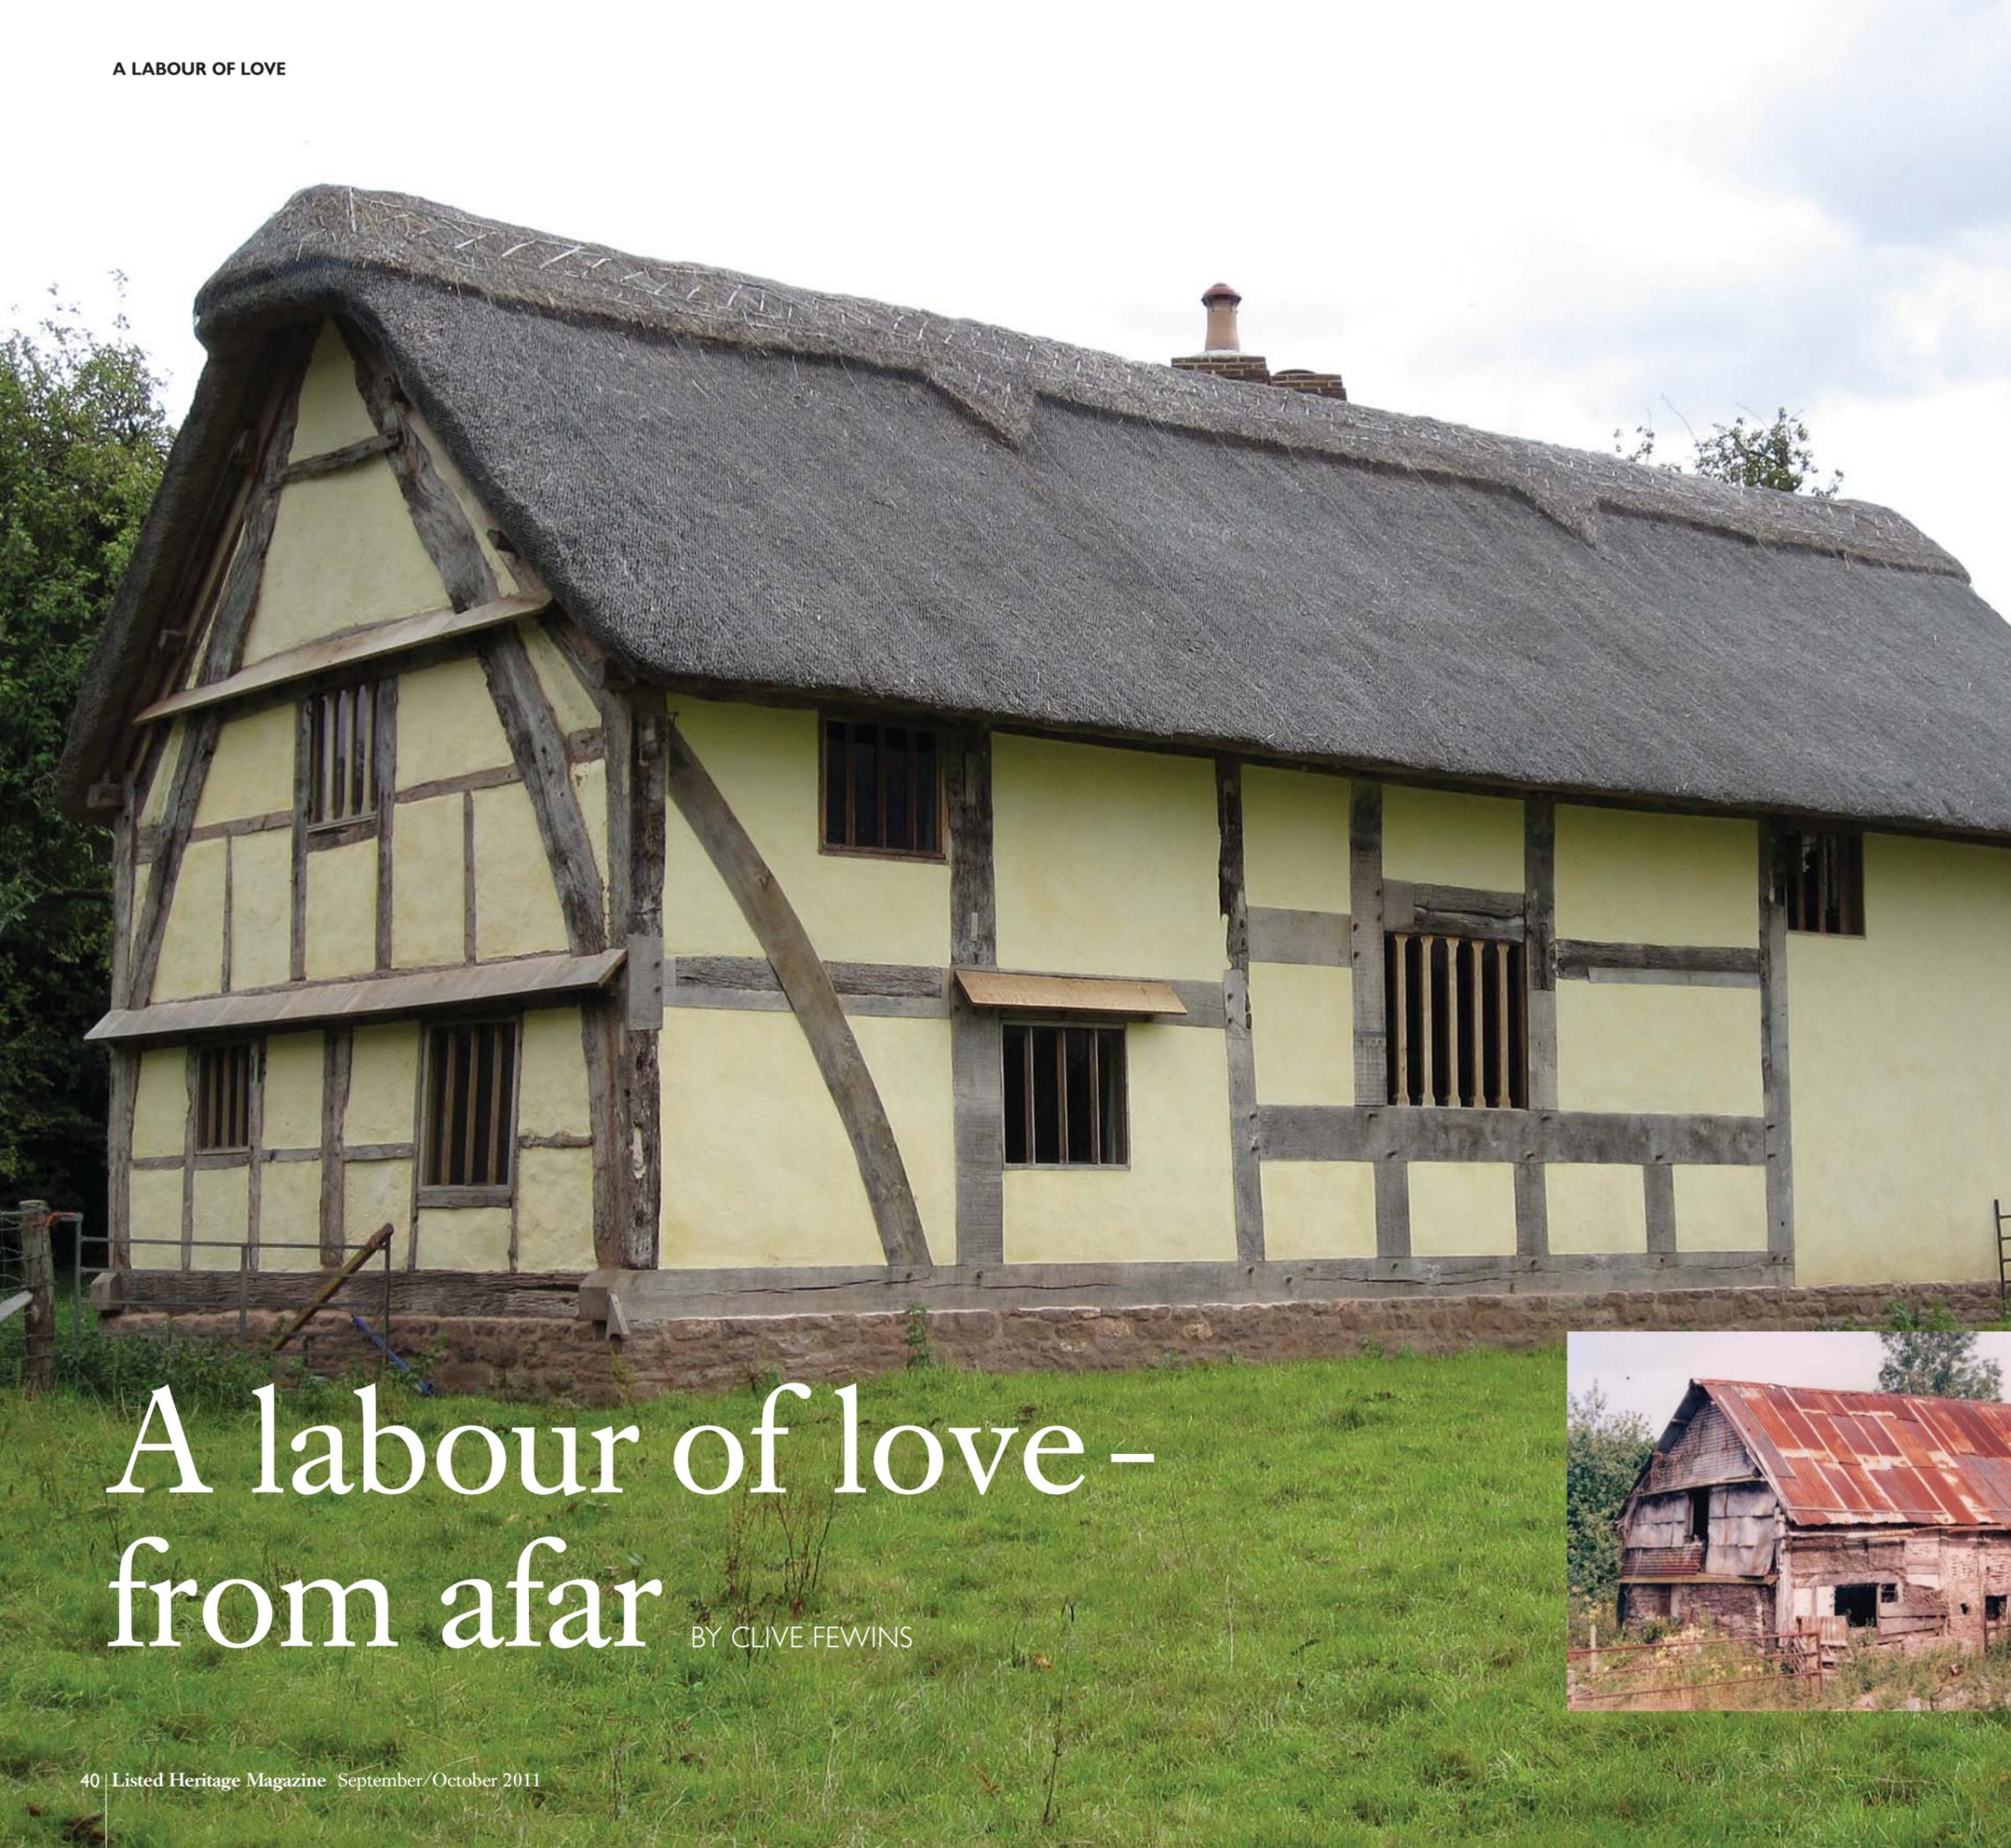
Main image:
A view of the completed exterior

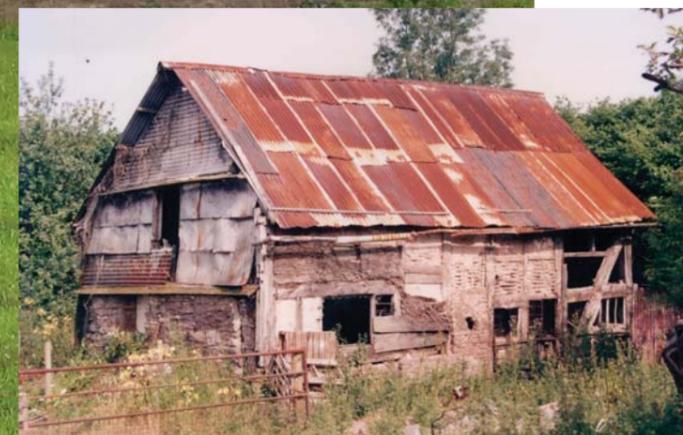
Inset:
The building as it was before the restoration

The old timber-framed building stood alone under its tin roof in a corner of a field on the boundary of the farm, ancient, unloved and occupied only by chickens

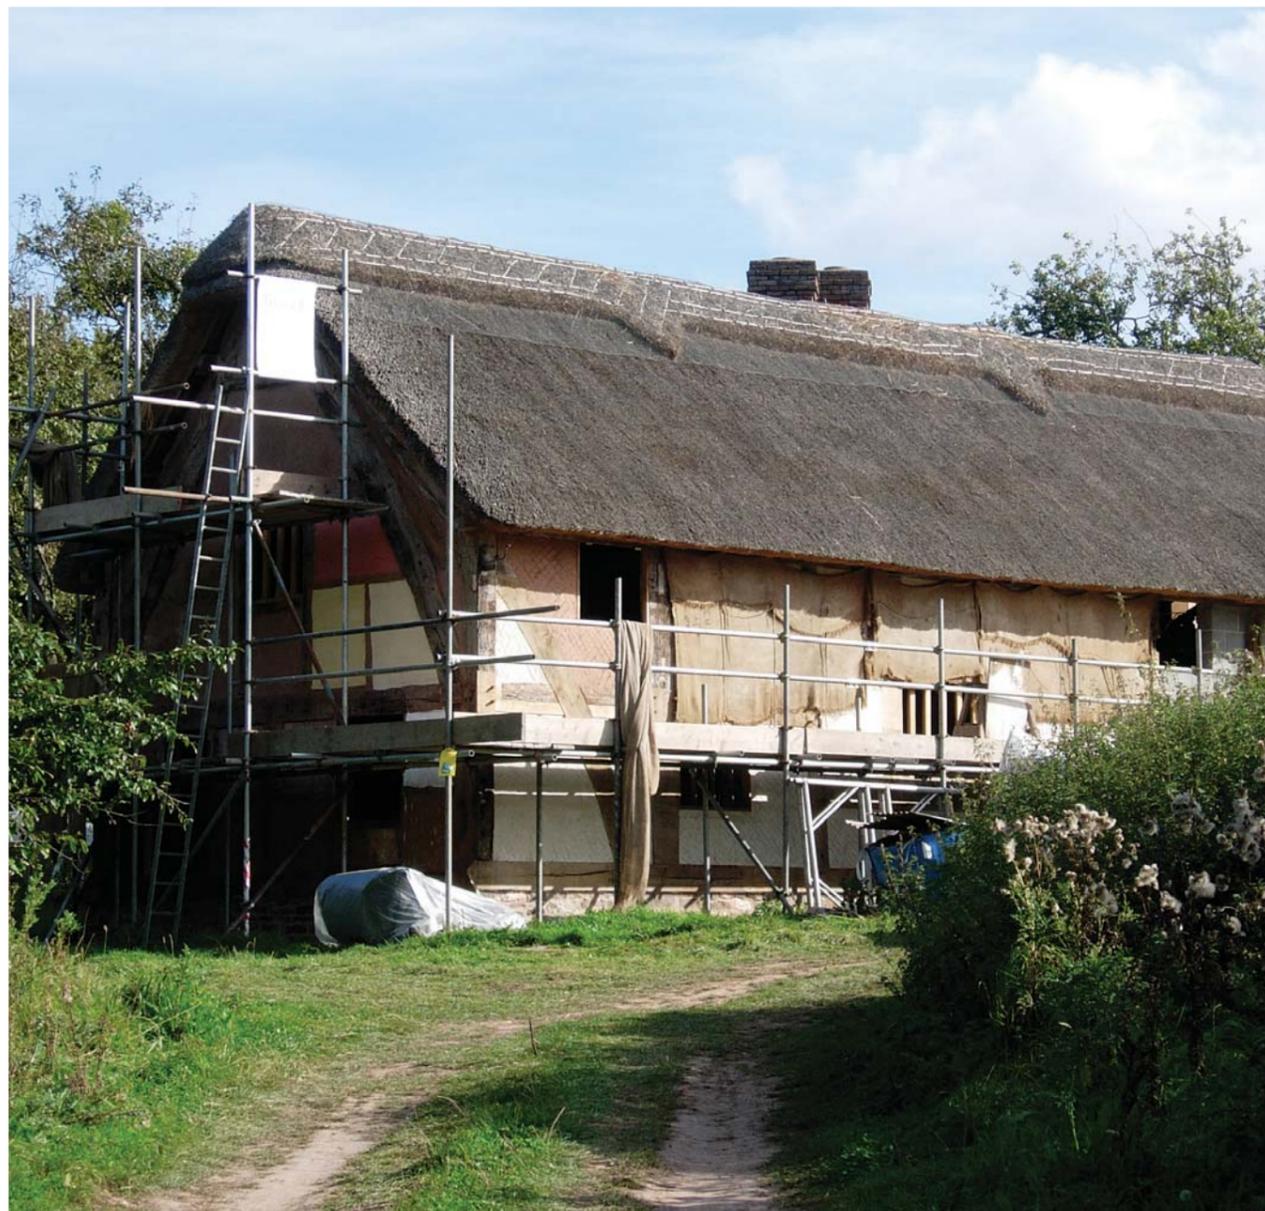
Above: When he was over from New Zealand Phil worked on most of the new wattle and daub infill panels

As well as Phil's own labour in undertaking all the internal woodwork and making the new infill panels from wattle and daub and also experimenting with some modern highly-energy retentive materials, a local builder has restored and repaired the cruck blades. He also built a sturdy chimney of local stone. Phil also worked on the windows and other sections of the frame, and

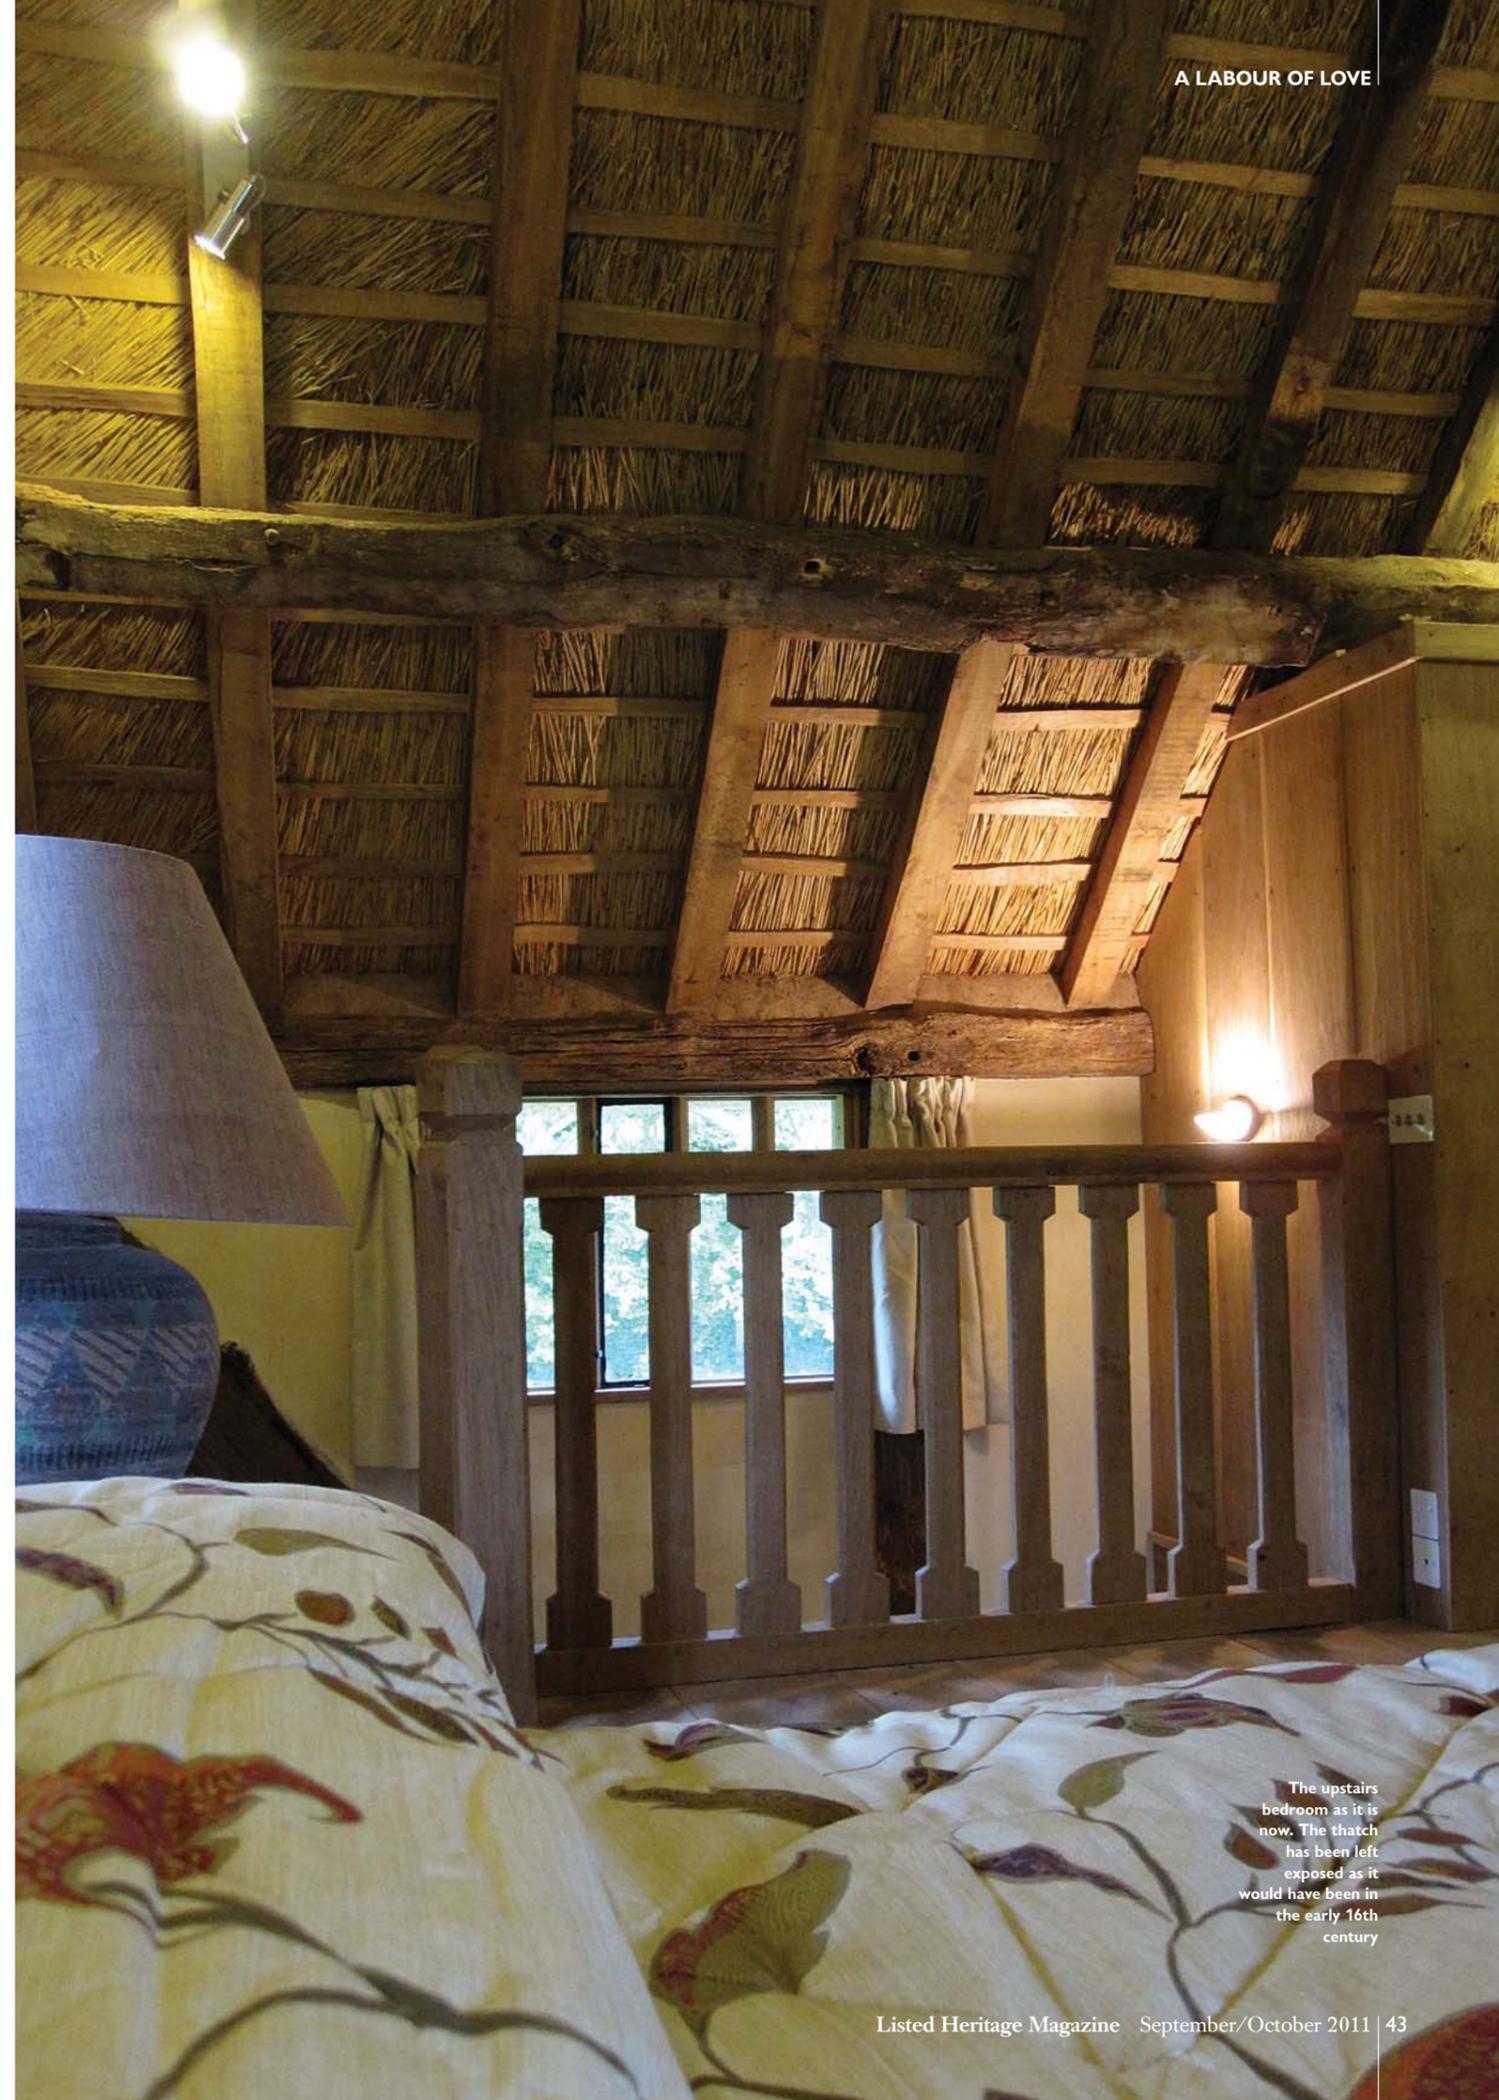
The upstairs bedroom as it is now. The thatch has been left exposed as it would have been in the early 16th century

Inside, the thatch is exposed, as it would have been in the early 16th century, and the incomplete rafters left as found at the point where the smoke from the fire in the central hearth is believed to have passed through a louvre in the roof.

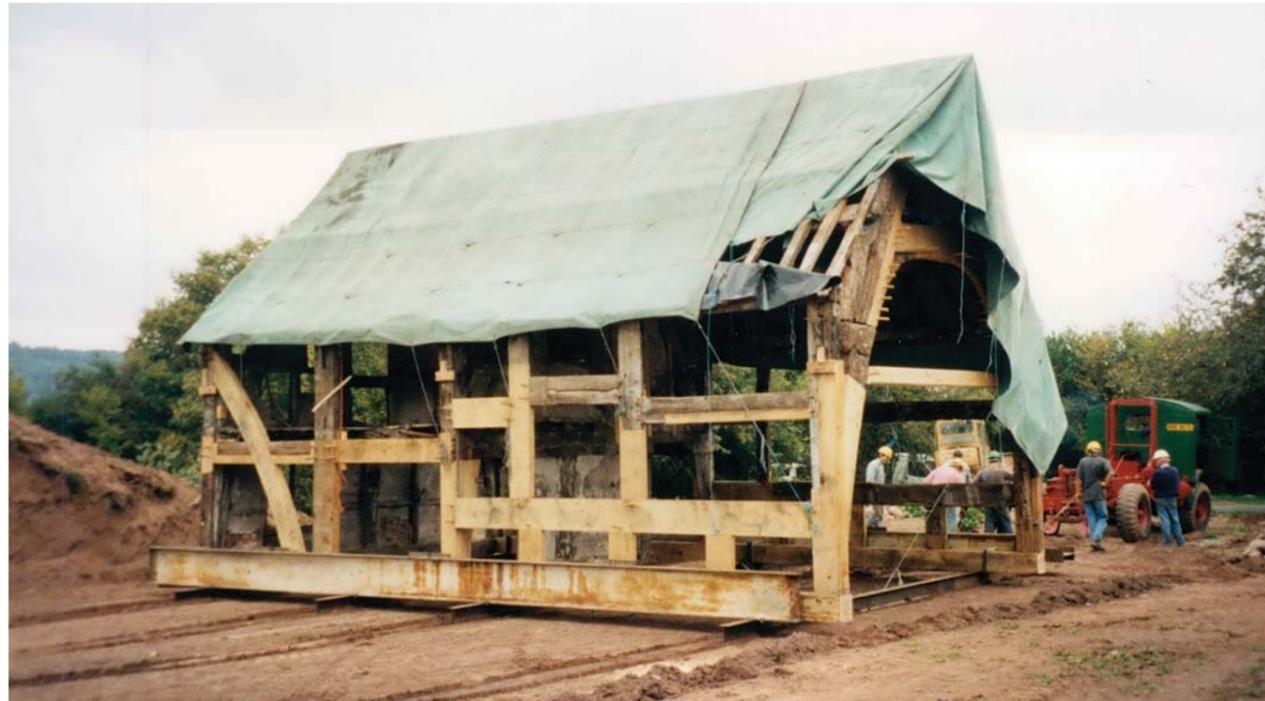
Top: When the timber frame had been strengthened and stabilised it was placed on a steel chassis and dragged by an old truck across the levelled ground to its new position

The frame was skillfully repaired, then jacked up. A steel chassis was created with the assistance of Phil's two cousins, and in 1995 an old Army winch truck slowly dragged the frame across the plot to its new position.

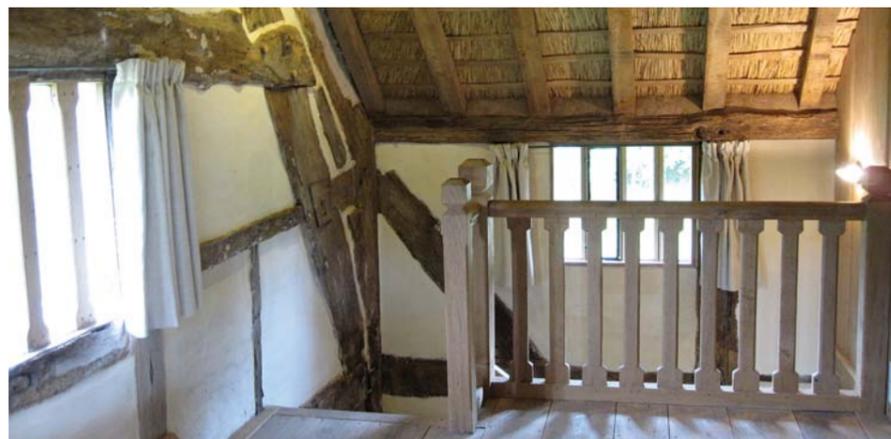
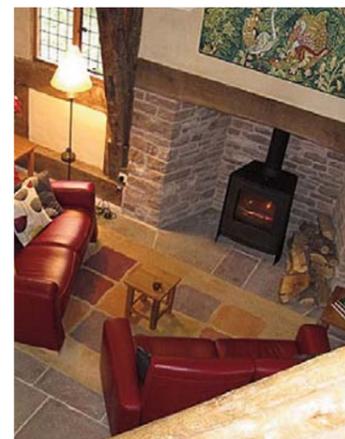
Bottom left: The gallery in the end of the building that has been rebuilt.

This very much follows the original layout, as has the partial plank and muntin screen recreated in oak at the far end, which has been rebuilt to what is believed to be the original plan using modern materials. The gallery at this end, which people renting the property will be able to use as a rest and relaxation area, is, as Phil admits, conjecture.
